CRYSTAL LAKE DAM

NJ00299

PHASE I INSPECTION REPORT.  
NATIONAL DAM SAFETY PROGRAM

| REPORT DOCUMENTATION PAGE | | READ INSTRUCTIONS<br>BEFORE COMPLETING FORM |
|--|---|--|
| 4. TITLE (and Subtitle)<br>Phase I Inspection Report<br>National Dam Safety Program<br>Crystal Lake Dam, NJ00299<br>Burlington County, NJ | | 5. TYPE OF REPORT & PERIOD COVERED<br>FINAL |

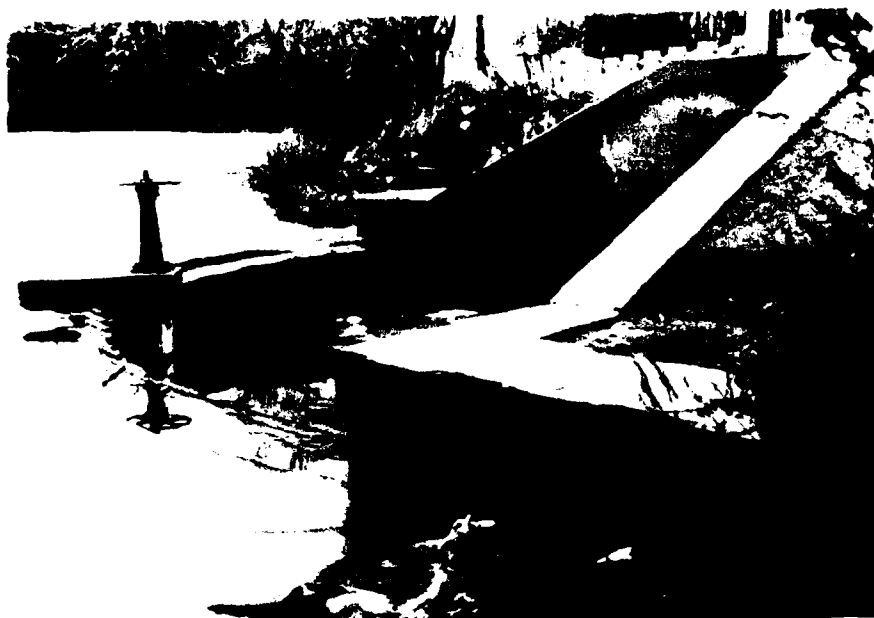
PHOTO 1  
SPILLWAY - LOOKING FROM RIGHT

The spillway crest was in the shape of a broad crested weir and was formed by two parallel rows of interlocking steel sheet piling. The sheet piling appeared to be sound and in generally satisfactory condition. The sheet piling extended from within the embankment on the left side, around the horse-shoe to within the embankment on the right side. The concrete spillway discharges onto a concrete apron which joins the downstream channel formed by the bridge opening.

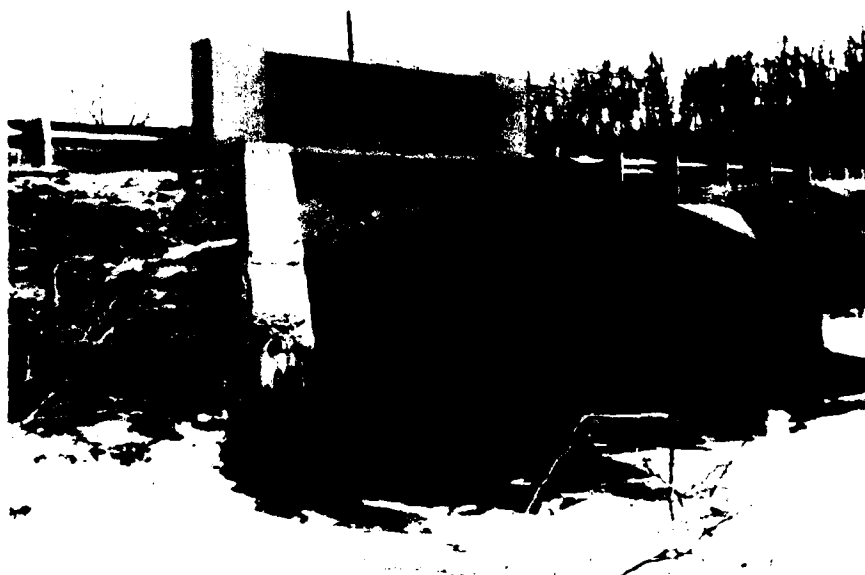
PHOTO 4  
DOWNSTREAM END OF BRIDGE

The concrete railings on both the upstream and downstream headwalls for the bridge appeared to be in satisfactory condition. The downstream wingwalls appeared to be generally sound with the top, or cap, of the right wingwall cracked and spalled at its downstream end. The left wingwall appeared to be in satisfactory condition.

| VISUAL EXAMINATION OF | OBSERVATIONS | REMARKS OR RECOMMENDATIONS |
|---|--|--|
| DISCHARGE CHANNEL | Upstream wingwalls and abutments in satisfactory condition, with some hairline cracks observed. Downstream wingwalls generally sound; the cap of the right wingwall cracked and spalled at its downstream end. | Discharge channel formed by concrete bridge abutments and wingwalls. |

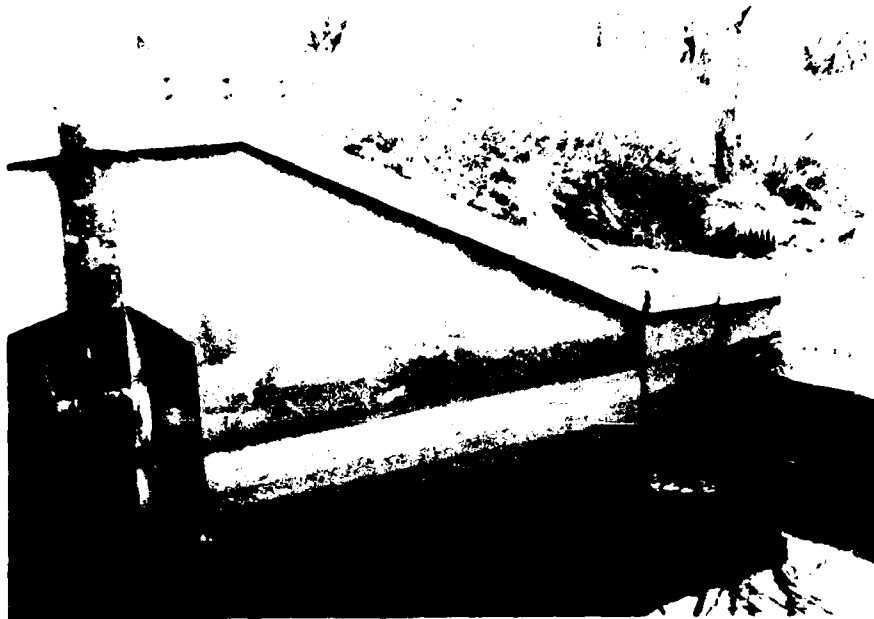
PHOTO 5  
UPSTREAM FACE OF DAM

The upstream face of the dam was slightly irregular and generally covered with weeds, bushes and trees ranging in caliper from 2 inches to 8 inches. The upstream side of the embankment adjacent to both wingwalls of the bridge structure was stabilized with asphalt which appeared to be in satisfactory condition, however, some erosion was observed just beyond the limit of the asphalt. In addition, there was evidence of some riprap on the upstream face of the dam, but it appeared to be inadequate.

| VISUAL EXAMINATION | OBSERVATIONS | REMARKS OR RECOMMENDATIONS |
|--|--|--|
| RIPRAP | Riprap on upstream face (12" stones) generally not adequate. Grouted riprap adjacent to right downstream wingwall of bridge generally adequate with some broken away at toe. | Upstream riprap should be renovated by adding more complete cover. Grouted riprap on downstream face should be renovated where required. |

(4) Deteriorating riprap on the upstream and downstream faces of embankment should be repaired where necessary.

(5) All trees and adverse vegetation on the embankment should be removed.

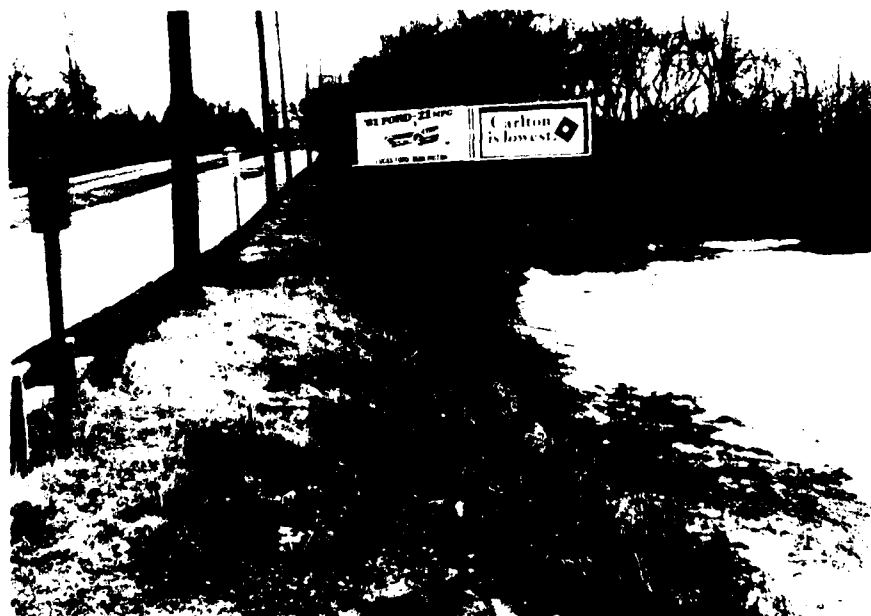
PHOTO 6  
DOWNSTREAM FACE OF DAM

| VISUAL EXAMINATION OF | OBSERVATIONS | REMARKS OR RECOMMENDATIONS |
|---|---|--|
| GENERAL | Paved highway on crest (Rt. 130) in satisfactory condition. Bushes, weeds and trees (2"-8") on upstream face. Trees on downstream face have been cut off approx. 1 foot from ground. Steel guide rails in good condition. | Trees should be removed. |

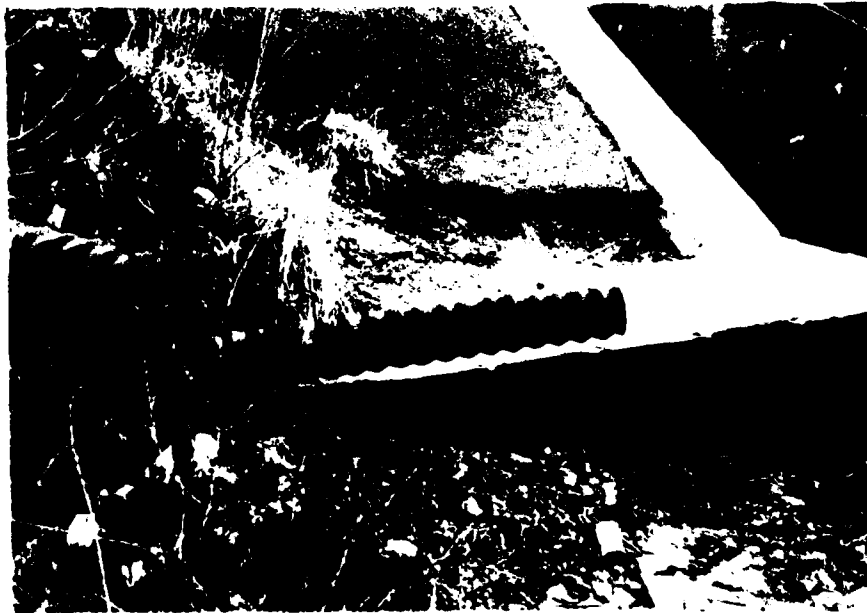
PHOTO 8

Two corrugated metal pipes were observed protruding from the embankment immediately to the left of the spillway on the upstream side. The smaller of the two did not appear to have an observable intake end and could possibly be a toe drain. The larger of the two was in poor condition, being significantly rusted with some of the surface rusted through and with no observable inlet structure on the road. An additional corrugated metal pipe was observed on the right side about 10 feet from the spillway and appeared to be in satisfactory condition.

| VISUAL EXAMINATION | OBSERVATIONS | REMARKS OR RECOMMENDATIONS |
|--|--|--|
| SLOUGHING OR EROSION OF EMBANKMENT AND ABUTMENT SLOPES | Upstream face slightly irregular in alignment; possibly due to wave erosion. Erosion from surface runoff observed adjacent to left, upstream wingwall of bridge. | Embankment stabilization adjacent to bridge should be renovated. |

BITUMINOUS SLOPE PROTECTION ADJACENT  
TO LEFT, UPSTREAM END OF BRIDGE.  
CORRUGATED METAL DRAINS IN FOREGROUND

(2) Rusted CMP surface drain pipe should be replaced by proper inlet and pipe.

(3) Erosion of the embankment adjacent to the upstream wingwalls of the bridge should be properly stabilized.
